LUMBER SCHOONER *COMET* RECENT RESULTS FROM FIELDWORK

Robert Schwemmer

This poster examines the recent exposure and field investigation of the bow section of a three-masted lumber schooner rediscovered at Simonton Cove, San Miguel Island. The 429.74-gross ton wooden sailing vessel was christened with the name *Comet* for her owners Hooper Brothers and C. F. S. Lass. The schooner was originally built in 1886 at the Hall Brothers shipbuilding firm of Port Blakely, Washington and was registered with the following dimensions (feet); length 144.6, breadth 35.2 and depth of hold 11.4. She was built of Douglas fir with the exception of her hardwood stem and stern post, and had an elliptic stern and billet head. Equipped with a centerboard, she had one deck, including bow and stern ports for loading lumber cargoes. During the *Comet's* twenty-five year career she delivered lumber to many coastal ports along the Pacific West Coast.

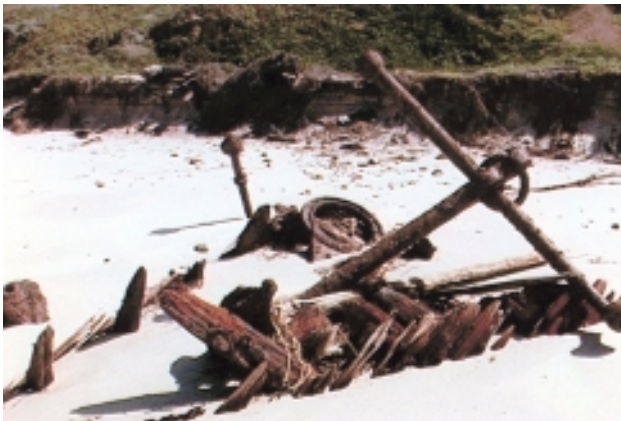
As revealed in the 1984 images, the sand had scoured down to a point exposing the anchor, capstan, and portions of the wooden bow structure (Figure 1). In addition, the sand terrace towards the interior of the island had eroded revealing iron machinery not documented in the earlier photographs. This new machinery was identified as two purchase rims that are components of the hand lever windlass system, and still attached to the rims are the pawls or traveler arms. The pawls would attach to connecting rods that went up to the pump brake mechanism located on the foredeck above the windless. The inner dimension of the purchase rims was recorded at 23.5 in. The original dimension would have been closer to 24 in. before iron expansion occurred due to years

Figure 1. The bow section of the *Comet* was exposed after being buried in sand for 15 years.

A multi-agency shipwreck reconnaissance team is scheduled for April 1999 to continue the field studies, assuming future storms do not cover the wreckage with sand. The multi-agency team will be represented by CINP, CINMS, SCRUI, SBMM, CMAR and the Mineral Management Service Pacific OCS Region (MMS). Not only will this information provide historical documentation of the little known construction methods during the latter part of the nineteenth century, but will be disseminated to the public at the Santa Barbara Maritime Museum's CINMS and CINP shipwreck exhibits.

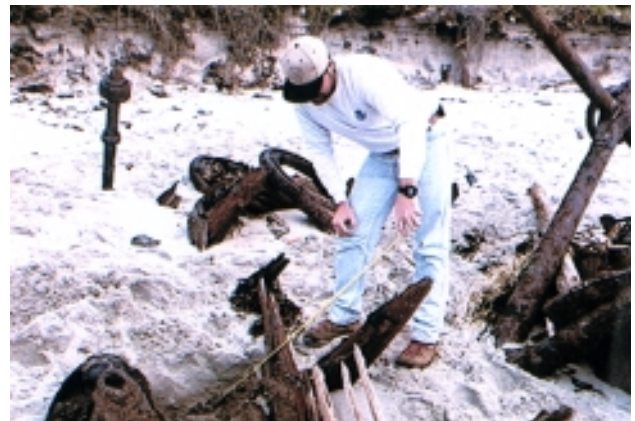
of exposure in the corrosive environment. This information was substantiated in the *Comet*'s surviving construction contract where it was stipulated the vessel was to be equipped with a 24-in. windlass purchase. Further study of the capstan revealed that it was still attached to the wooden foredeck, which greatly assists archaeologists in comparing the site dimensions to the wooden dimensions called out in the construction contract, confirming the vessel's identity. Schwemmer spent the next four hours recording the site, taking field drawings, and photographs before the storm arrived (Figure 2). After the initial investigation of the *Comet* site it was recommended that a more detailed study be conducted during favorable weather and tide conditions.

Figure 2. R. Schwemmer measuring the *Comet*'s capstan and wooden fore deck.
